Exterior Lighting Assessment

Saguaro National Park

NPS NATURAL SOUNDS AND NIGHT SKIES DIVISION

September 2020

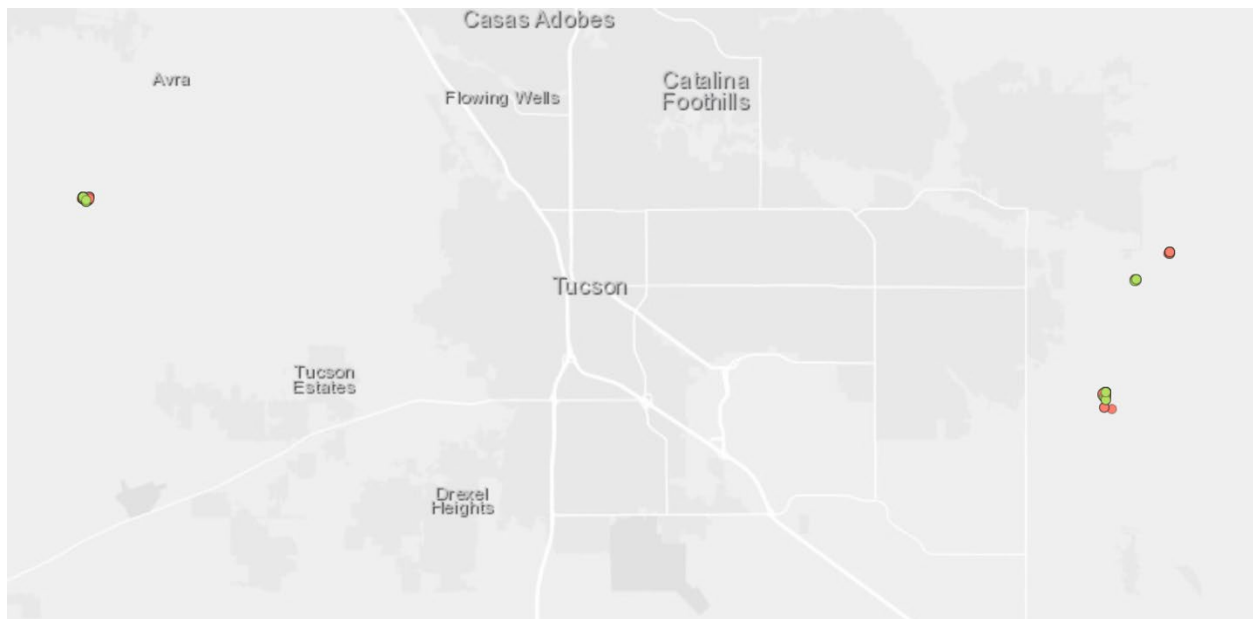
Overall, 188 individual fixtures were identified and characterized during the on-site visit (Figure 1). Currently, 61.7% (116 fixtures) of exterior artificial lighting within Saguaro National Park is compliant with IDA’s lighting guidelines. The breakdown of fixtures within each main Park area is presented in Table 1.

Figure 1. Fixtures Identified within Saguaro National Park. Dots indicate locations of existing fixtures.

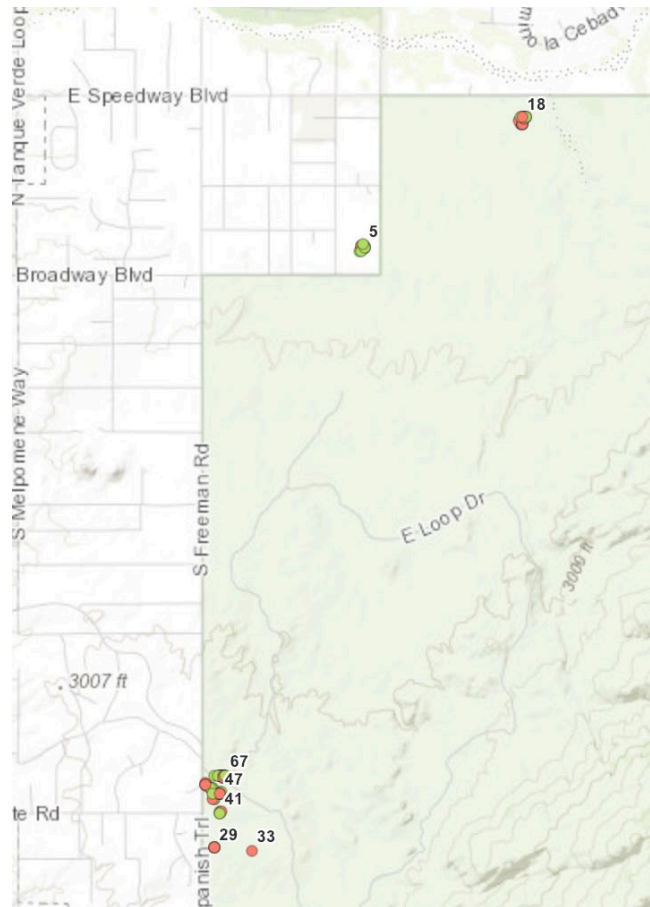
There were 88 identified fixtures within the Rincon Mountain District (Figure 2). 47.7% (42 fixtures) of the lighting in the district is compliant with IDA lighting guidelines. The Rincon Mountain District contains the Fire Operations Complex; Greene Property; Heli Pad / Magnetic Observatory; Quarters 14, 15, and 16; the Horse Corral, the Headquarters Building, the Visitor Center area, and the Maintenance Area. Details of each facility within the area follow within this subsection.

Figure 2. Fixtures Identified within the East Unit of Saguaro National Park. Dark sky compliant lighting has a green marker and non-compliant lighting has a red marker. Details follow within this subsection.

There are a total of 46 fixtures recommended for retrofitting using 32 different change outs across the Rincon Mountain District. A summary of the recommended retrofits is presented in Tables 17a and 17b, with additional details (concerning each fixtures location and replacement recommendation) provided in the text and figures following the table.

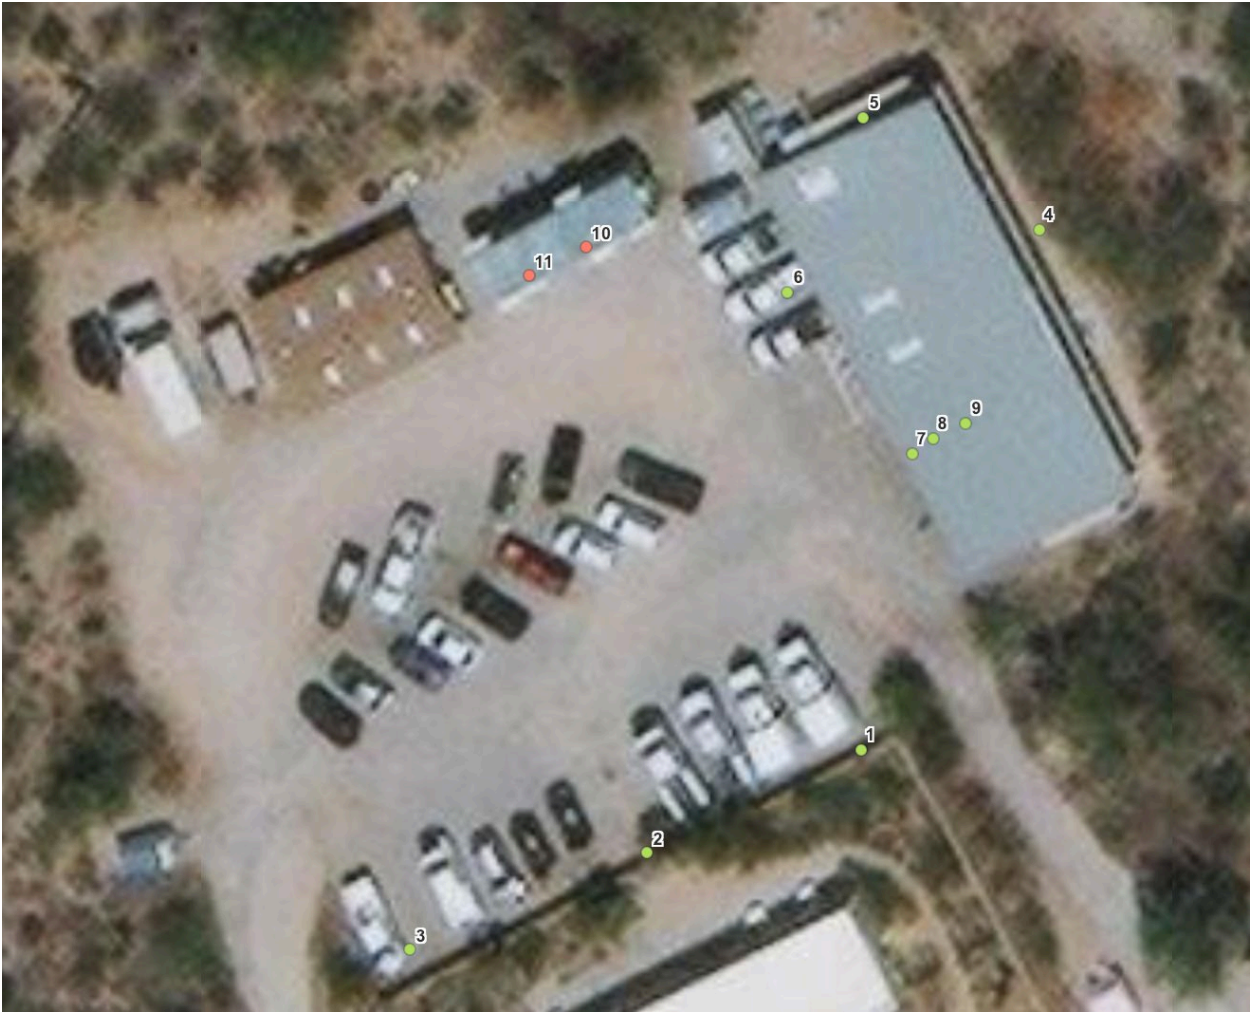
There were 11 identified fixtures within the Fire Operations Complex (Figure 3). 81.8% (9 fixtures) of the existing lighting in this complex is compliant with IDA lighting guidelines. A summary of all the lighting in this area is presented in Table 3.

Figure 3. Fixture Compliance with Dark Sky Guidelines for the Fire Operations Complex. Dark sky compliant lighting has a green marker and non-compliant lighting has a red marker.

There are two fixtures that are recommended for replacement. Fixtures 11 and 12 are non-compliant wall sconces on the outside of the trailer. They are recommended for replacement with the fully-shielded wall cylinder fixture equipped with a new A19-27L lamp (WC5 + A19-27L). Their location, along with the replacement details for each fixture ID presented, is shown in Figure 17.

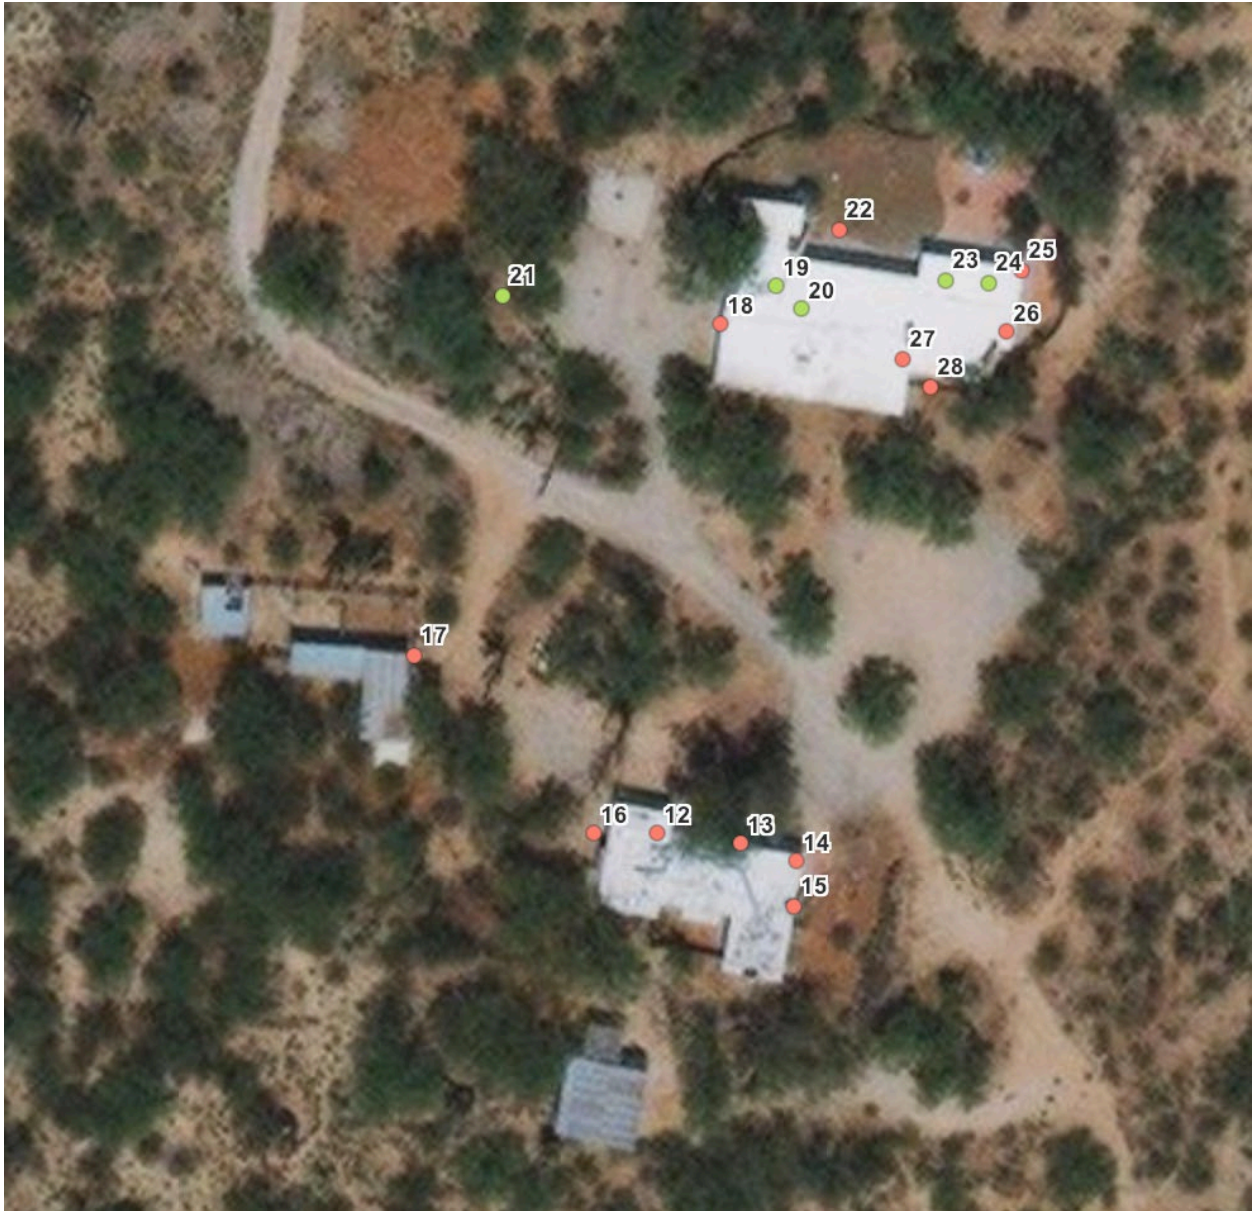
There were 17 identified fixtures throughout the Greene Property (Figure 4). 29.4% (5 fixtures) of the existing fixtures at the property are compliant with IDA lighting guidelines. A summary of all the lighting in this area is presented in Table 4.

Figure 4. Fixture Compliance with Dark Sky Guidelines for Visitor Center Area Bollards. Dark sky compliant lighting has a green marker and non-compliant lighting has a red marker.

There are 12 fixtures that are recommended for replacement. I realize that this location will undergo significant changes within the next few years. For the purposes of planning though, I'm recommending that fixtures not used for entrance/egress be removed. These fixtures include fixtures # 14, 17, 18, 22, 25, 26, and 28. For fixtures required for entrance/egress (fixtures # 12, 13, 15, 16, and 27), these fixtures can be relamped with a new compliant A19-27L lamp. This lamp provides low lumen illumination and can be used in locations where historical concerns exist due to the presence of period, but unshielded lighting fixtures. The location for the recommended retrofits, along with the replacement details for each fixture ID presented, is shown in Figure 18.

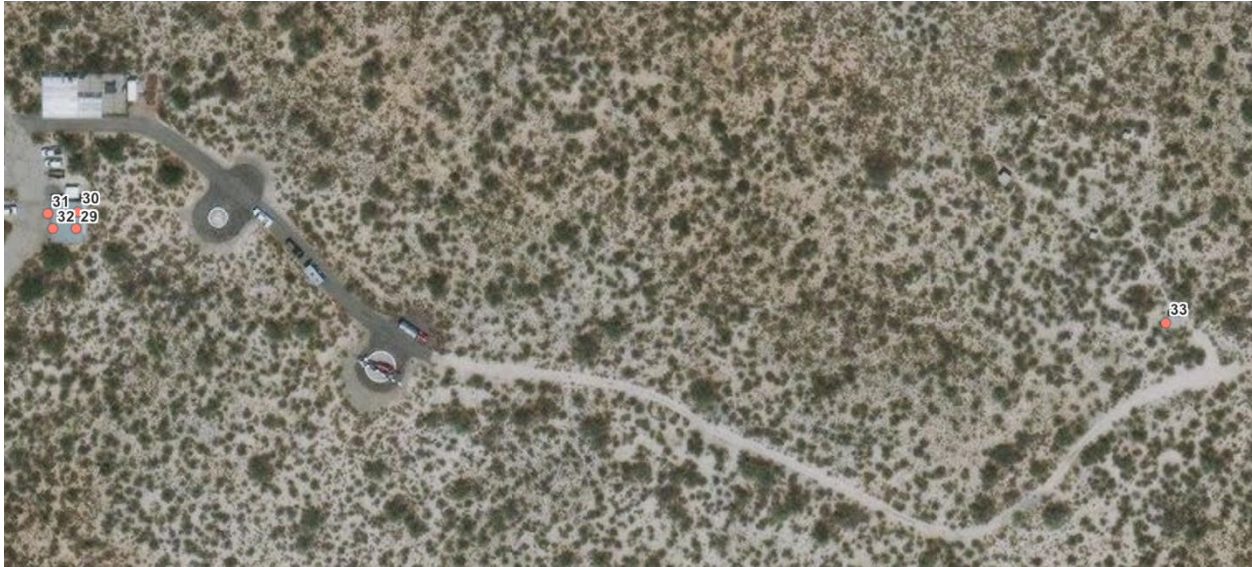
There are 5 identified fixtures in this area (Figure 5). None of the existing lighting is compliant with IDA lighting guidelines. A summary of all the lighting in this area is presented in Table 5.

Figure 5. Fixture Compliance with Dark Sky Guidelines for the Heli Pad / Magnetic Observatory Area. Dark sky compliant lighting has a green marker and non-compliant lighting has a red marker.

There are 5 fixtures that are recommended for replacement. The replacement recommendations for the Heli-Pad building include replacing wall pack fixtures # 31 and 32 with the specified wall cylinder fixture equipped with the A19-27L lamp (WC5 + A19-27L). The other two replacements on this building include replacing the two existing ceiling mount fixtures (#29 and 30) under the overhang with the specified ceiling mount cylinders also equipped with the A19-27L lamp (CC5 + A19-27L). For the magnetic observatory, the non-compliant fixture (#33) over the access door can be replaced with the wall cylinder fixture (WC5 + A19-27L). Fixture #33 provides egress to a non-occupied building and could likely be removed instead of replaced, particularly due to the nature of the monitoring facility. However, anyone making the decision to remove this fixture will have to make sure its removal is in accordance with existing codes. The location of the recommended retrofits, along with the replacement details for each fixture ID presented, is shown in Figure 19a (Heli Pad) and 19b (Magnetic Observatory).

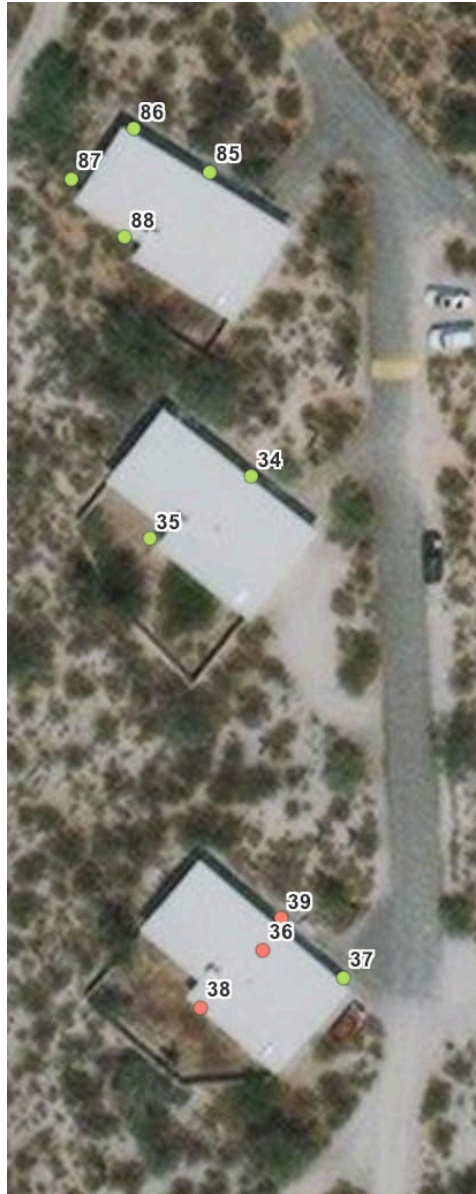
There were 10 identified fixtures on the residential quarters in the Rincon Mountain District (Figure 6). 70% (7 fixtures) of the existing lighting is compliant with IDA lighting guidelines. A summary of all the lighting in this area is presented in Table 6.

Figure 6. Fixture Compliance with Dark Sky Guidelines for Quarters 14, 15, and 16. Dark sky compliant lighting has a green marker and non-compliant lighting has a red marker.

There are 3 fixtures that are recommended for replacement. Fixtures #36, 38, and 39, all present on Quarters 16, are recommended for replacement with the specified wall cylinder fixture and A19-27L lamps (WC5 + A19-27L). Fixtures on the other two quarters are all compliant. The location of the retrofits proposed for Quarters 16, along with the replacement details for each fixture ID presented, is shown in Figure 20.

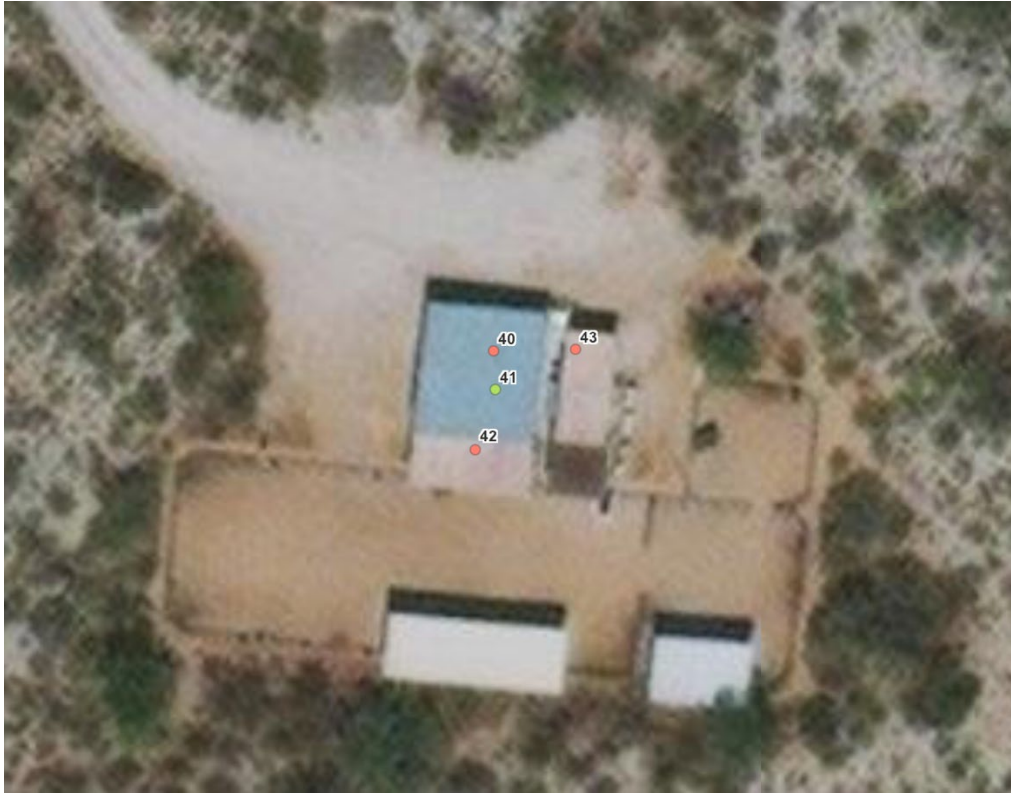
There were 4 identified fixtures on the horse corral (Figure 7). 25% (1 fixture) of the existing lighting is compliant with IDA lighting guidelines. A summary of all the lighting in this area is present in Table 7.

Figure 7. Fixture Compliance with Dark Sky Guidelines for the Horse Corral. Dark sky compliant lighting has a green marker and non-compliant lighting has a red marker.

There are 3 fixtures recommended for retrofit using one timer switch at the horse corral. The timer switch can be used in place of the existing flip switch. Their location, along with the replacement details for each fixture ID presented, is shown in Figure 20.

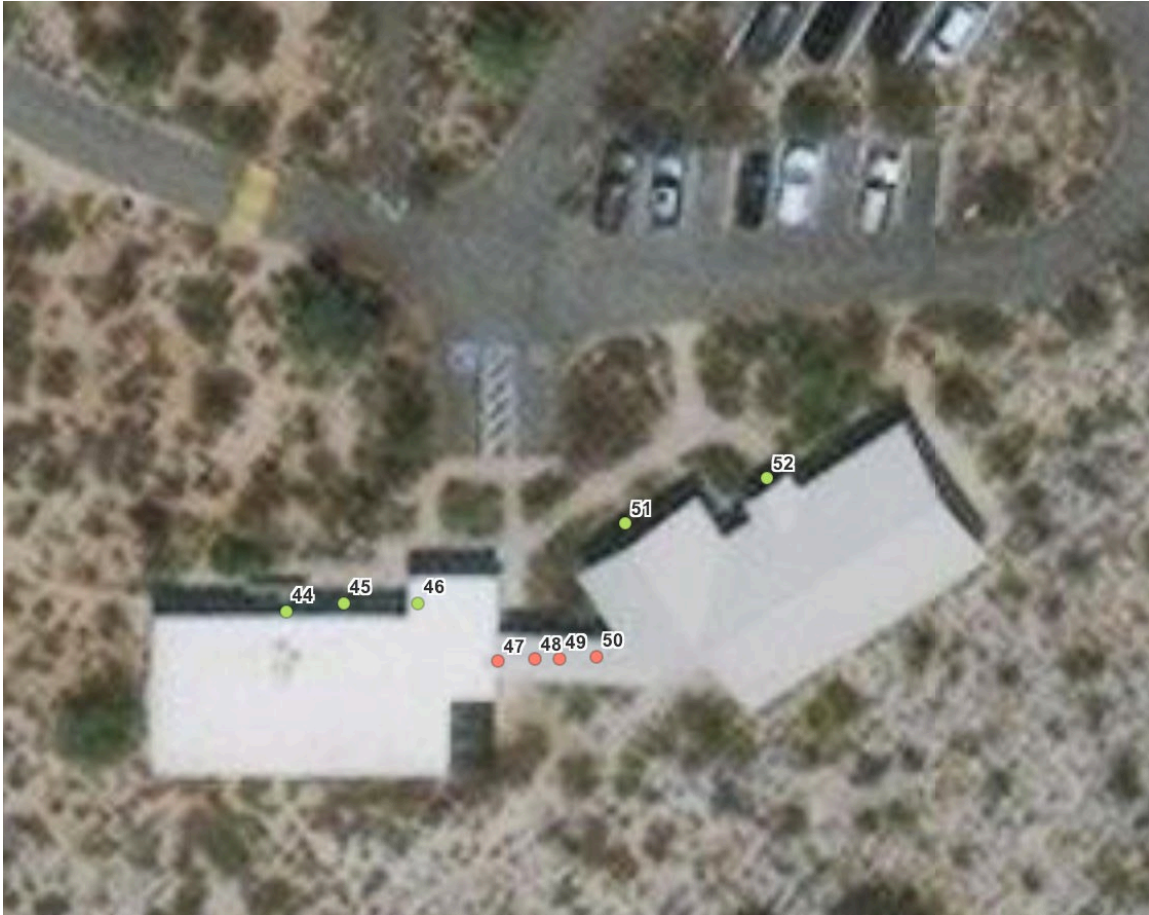
There were 9 identified fixtures within the Headquarters Building and Annex (Figure 8). 55.5% (5 fixtures) of lighting on the Headquarters Building is compliant with IDA lighting guidelines. A summary of all the lighting in this area is present in Table 8.

Figure 8. Fixture Compliance with Dark Sky Guidelines for the Headquarters Building and Annex. Dark sky compliant lighting has a green marker and non-compliant lighting has a red marker.

There are 4 fixtures (# 47-50) that are recommended for replacement. The retrofit for these four unshielded ceiling mount fixtures is the specified ceiling mount fixture with new A19-27L lamps (CC5 + A19-27L). Their location, along with the replacement details for each fixture ID presented, is shown in Figure 21.

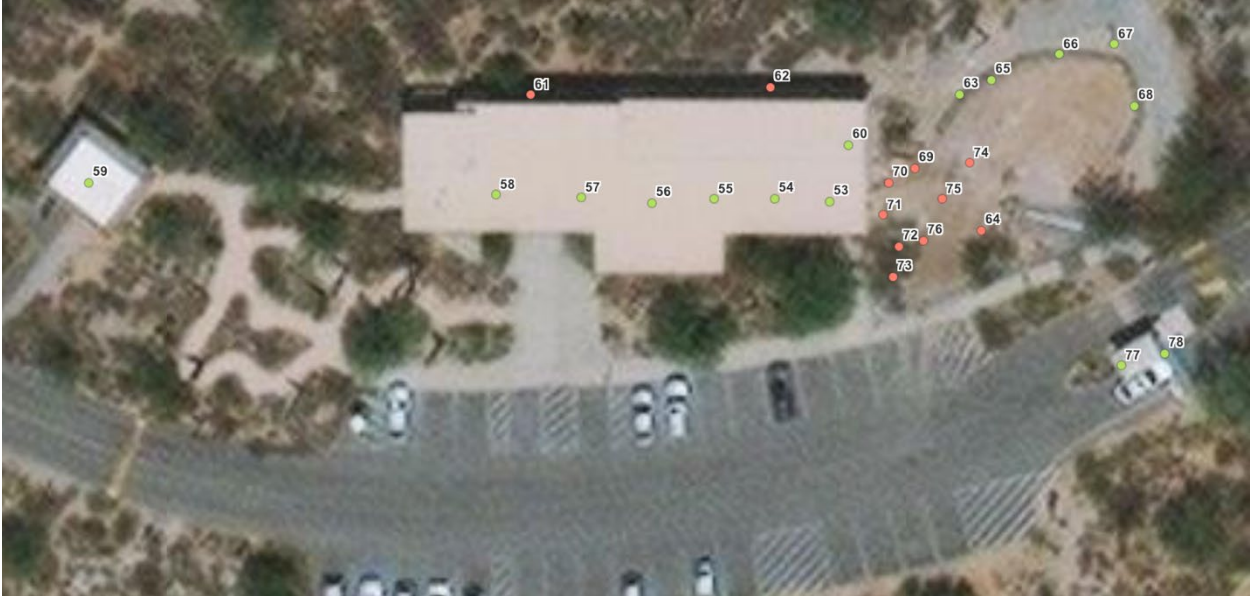
There were 26 identified fixtures in and around the Visitor Center (Figure 9). 56.7% (15 fixtures) of the existing lighting is compliant with IDA lighting guidelines. A summary of all the lighting in this area is present in Table 9.

Figure 9. Fixture Compliance with Dark Sky Guidelines for the Rincon Mountain Visitor Center Area. Dark sky compliant lighting has a green marker and non-compliant lighting has a red marker.

There are 3 fixtures that are recommended for replacement. Fixtures #61 and 62 are recommended for relamping with the A19-27L lamp. Fixtures # 64-76, while listed at 3000K and recently added, are not fully shielded in my opinion. Fortunately, they can be brought into compliance by inserting a timer switch into the circuit. One timer switch will retrofit this issue (and likely also then control the recessed lighting along the wall in the open area, as well). The location of the retrofit recommendations, along with the replacement details for each fixture ID presented, is shown in Figure 22.

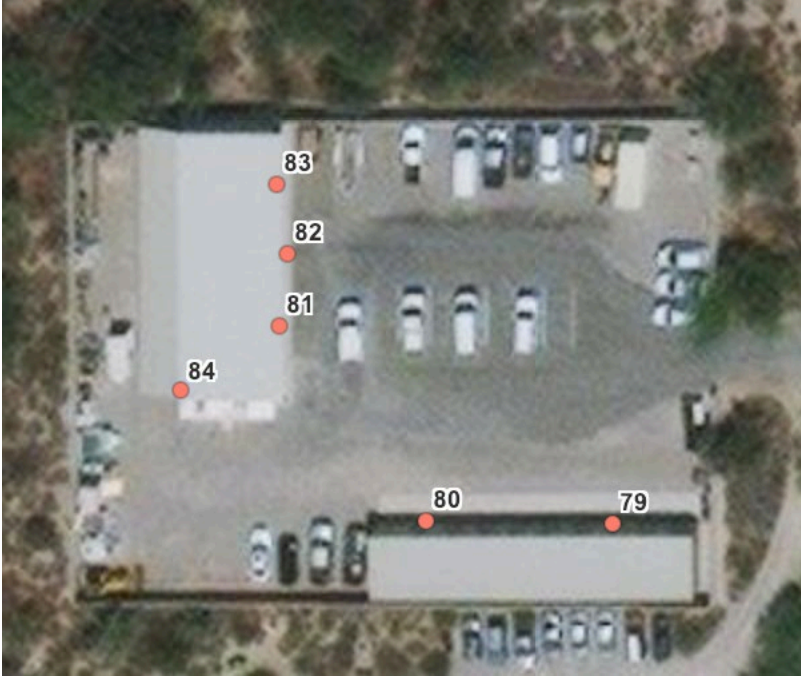
There were 6 identified fixtures in the Rincon Mountain District Maintenance Area (Figure 10). None of the existing lighting is compliant with IDA lighting guidelines. A summary of all the lighting in this area is present in Table 10.

Figure 10. Fixture Compliance with Dark Sky Guidelines for the Rincon Mountain District Maintenance Area. Dark sky compliant lighting has a green marker and non-compliant lighting has a red marker.

There are 5 fixtures that are recommended for retrofitting using timer switches. I inferred that there will be a total of two timer switches needed (one per each building), however, this will need to be confirmed prior to making the retrofits. Additionally, it may be desirable to instead retrofit each building with a motion sensor that will trigger the lights when someone approaches. This is another acceptable location that would take a little more planning. However, both solutions are acceptable from a dark sky certification point of view. The location of the fixtures requiring a retrofit, along with the replacement details for each fixture ID presented, is shown in Figure 23.

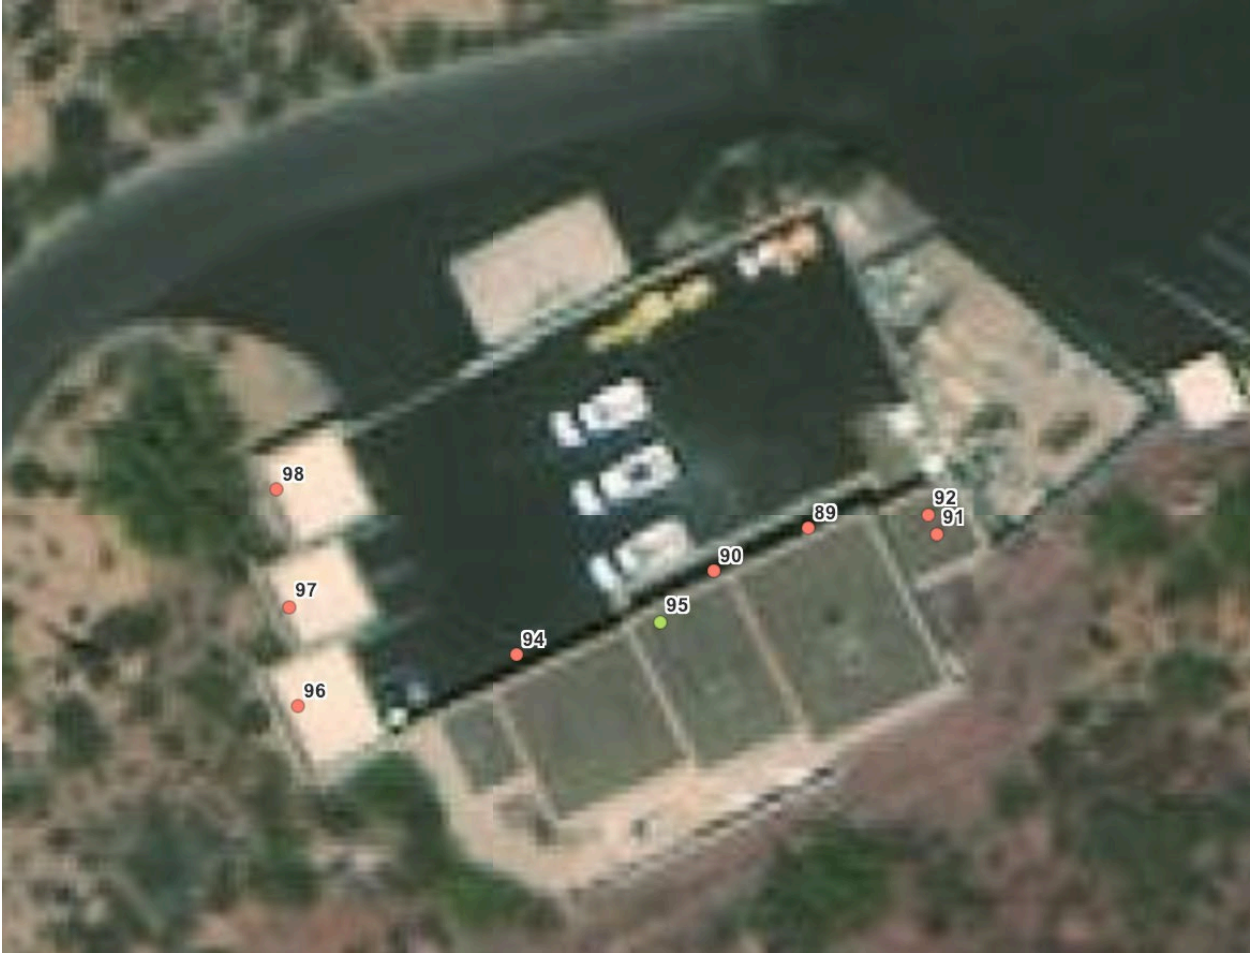
There were 10 identified fixtures within the Tucson Mountain District Maintenance Area (Figure 12). 10% (1 fixture) of the exterior lighting in this area is compliant with IDA lighting guidelines. A summary of all the lighting in this area is present in Table 12.

Figure 12. Fixtures Identified within the Tucson Mountain District Maintenance Area. Dark sky compliant lighting has a green marker and non-compliant lighting has a red marker.

There are 9 fixtures that are recommended for retrofitting. Fixtures #91 and 92 can be retrofitted using a timer switch. The specified replacement for the existing non-shielded wall pack fixtures 89, 90, and 93-98 is the fully shielded wall cylinder containing A19-27L lamps (WC5 + A19-27L). The retrofit locations, along with the replacement details for each fixture ID presented, is shown in Figure 24.

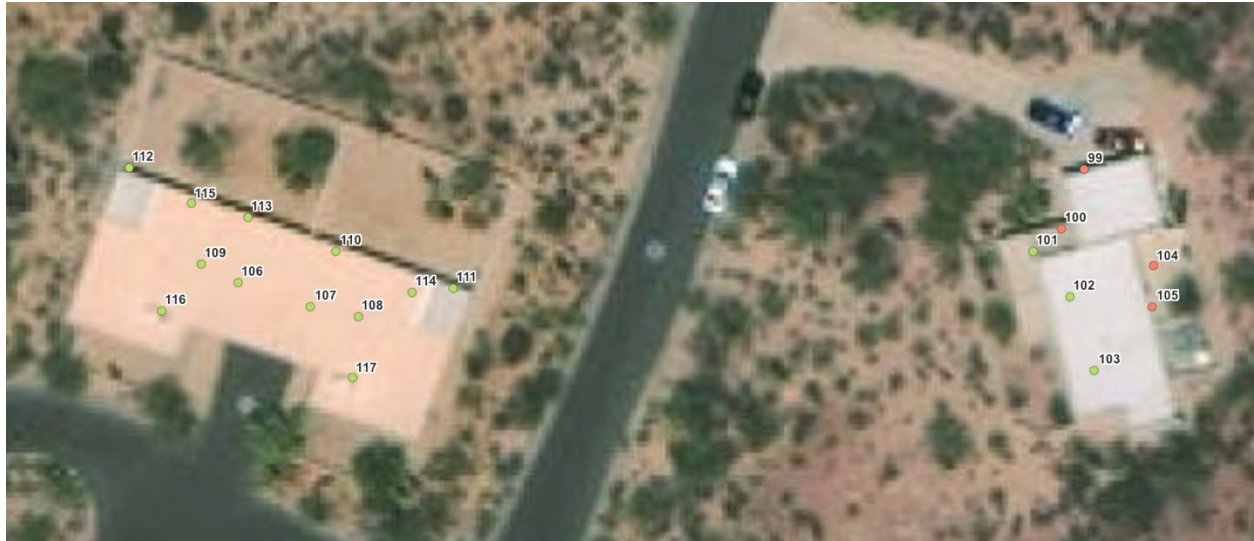
There were 19 identified fixtures present on Quarters 30, 31, and 32. 78.9% (15 fixtures) of the exterior lighting in these buildings is compliant with IDA lighting guidelines. A summary of all the lighting in this area is present in Table 13.

Figure 13. Fixture Compliance with Dark Sky Guidelines for Quarters 30, 31, and 32. Dark sky compliant lighting has a green marker and non-compliant lighting has a red marker.

Existing unshielded fixtures located on Quarters 30 at #99, 100, 104, and 105 are recommended for replacement with the specified wall cylinder with new A19-27L lamps (WC5 + A19-27L). Fixtures on Quarters 31 and 32 are compliant. The retrofit locations on Quarters 30, along with the replacement details for each fixture ID presented, is shown in Figure 25.

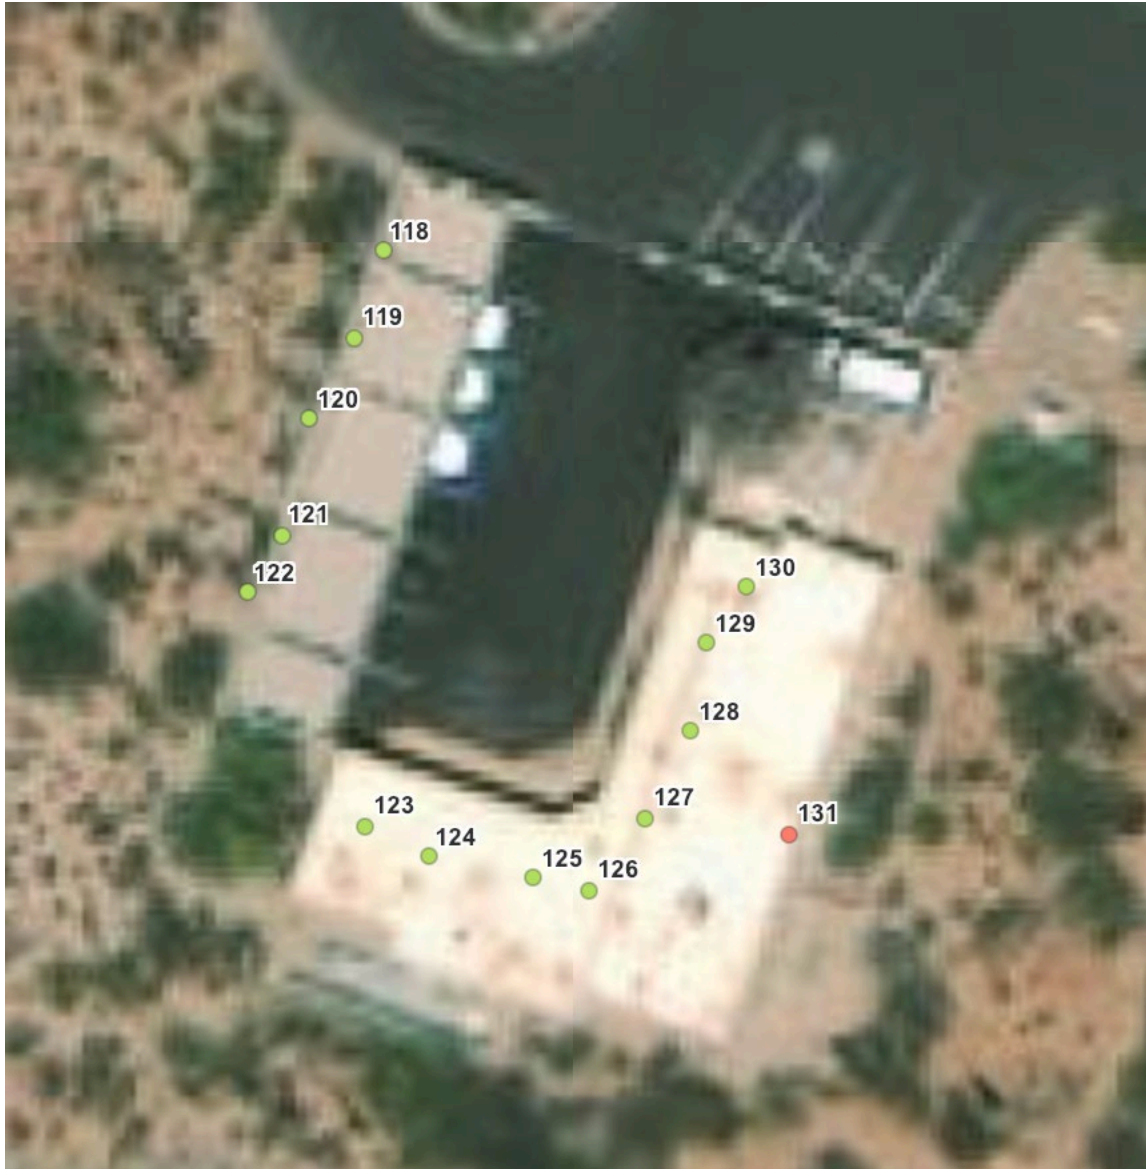
There were 14 identified fixtures present on the Operations Building. 92.9% (13 fixtures) of the exterior lighting on the Operations Building is compliant with IDA lighting guidelines. A summary of all the lighting on the building is present in Table 14.

Figure 14. Fixture Compliance with Dark Sky Guidelines for the Operations Building. Dark sky compliant lighting has a green marker and non-compliant lighting has a red marker.

Fixture #131, located on the rear porch area of the Operations Building, is recommended for replacement with the specified wall cylinder fixture and A19-27L lamp (WC5 + A19-27L). It's location, along with the replacement detail for fixture 131, is shown in Figure 26. The rest of the fixtures observed at the Operations Building were said to be activated by motion sensors.

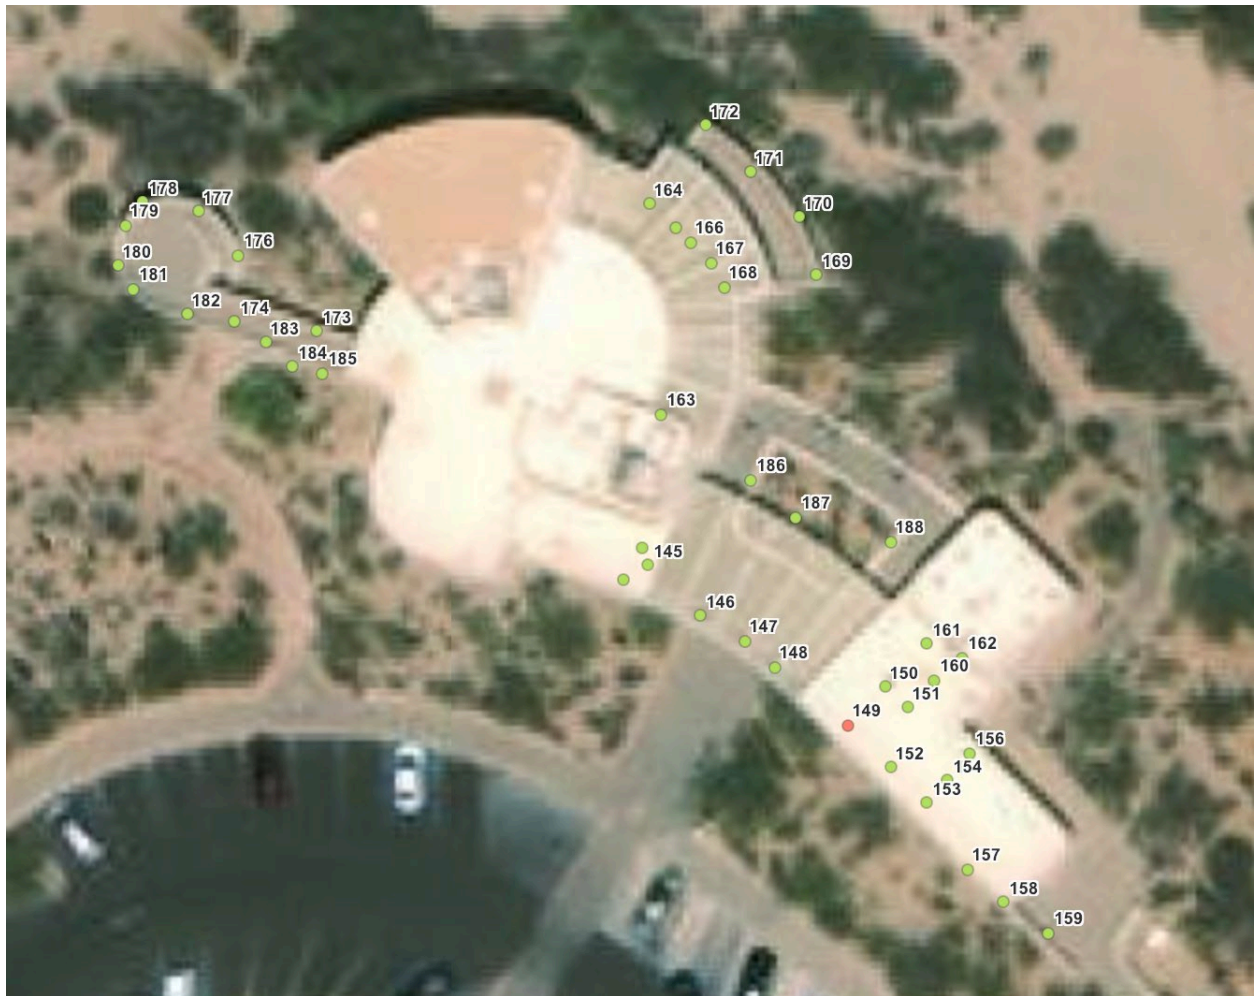
There were 57 identified fixtures within the Red Hills Visitor Center Area. 78.8% (45 fixtures) of the existing lighting in the vicinity of the Visitor Center is compliant with IDA lighting guidelines. Figure 15a provides compliance and locations of the lighting associated with the visitor center building. Figure 15b provides compliance and locations for the parking lot bollard fixtures. A summary of all the lighting in this area is present in Tables 15a and 15b.

Figure 15a. Fixture Compliance with Dark Sky Guidelines for the Red Hills Visitor Center Building. Dark sky compliant lighting has a green marker and non-compliant lighting has a red marker.

There are 11 bollard fixtures in the parking lot and one lamp on the visitor center recommended for replacement. The parking lot bollards are recommended for replacement with new fully shielded and correct color temperature bollards (BOL). For cost savings, bollards #134 and 135 could be replaced and the rest could be removed. Fixture 149 on the visitor center had a lamp that was not compliant due to color temperature (4000K). This lamp should be replaced with the A19-27L lamp. The retrofit locations, along with the replacement details for each fixture ID presented, is shown in Figure 27.

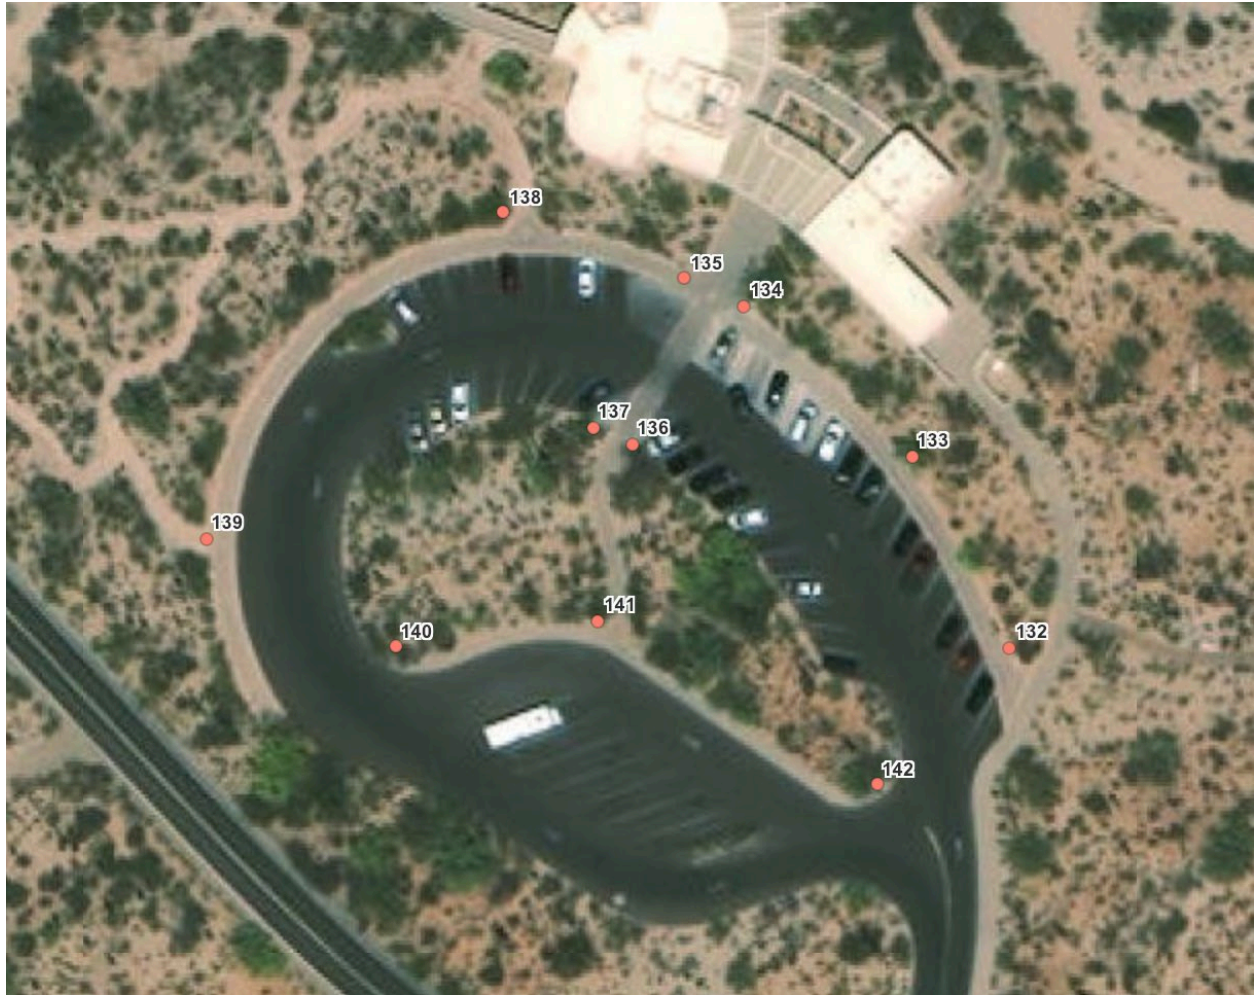
Figure 15b. Fixture Compliance with Dark Sky Guidelines for the Red Hills Visitor Center Parking Lot Bollards. Dark sky compliant lighting has a green marker and non-compliant lighting has a red marker.

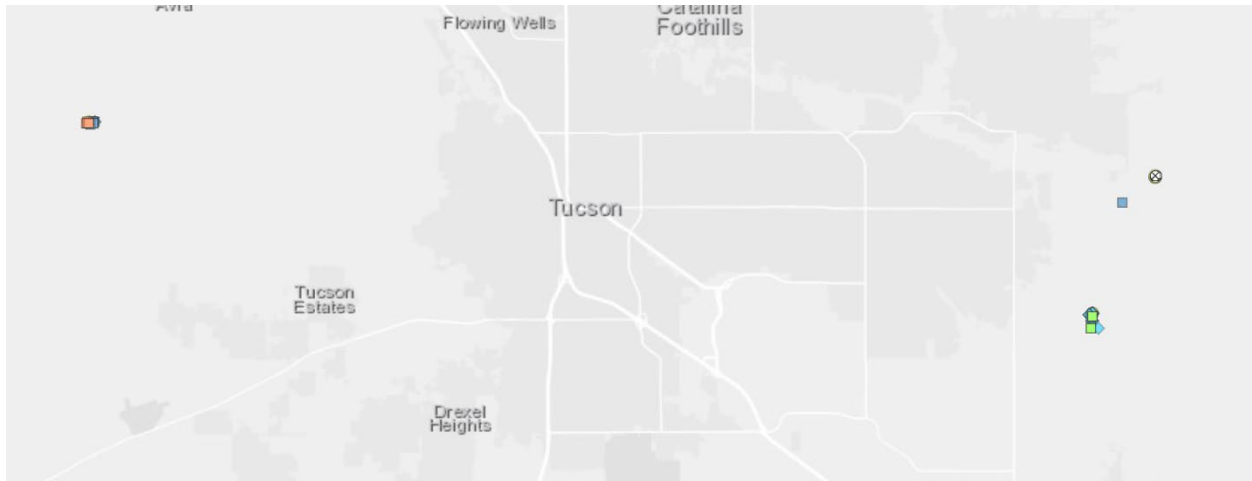
Figure 16. Generalized Location of Specified Replacements within Saguaro National Park.
